DISCOLORED WATER: CAUSES AND WHAT'S BEING DONE TO FIX IT

TOWN OF SCITUATE

Public Meeting August 13, 2018

Tighe&Bond

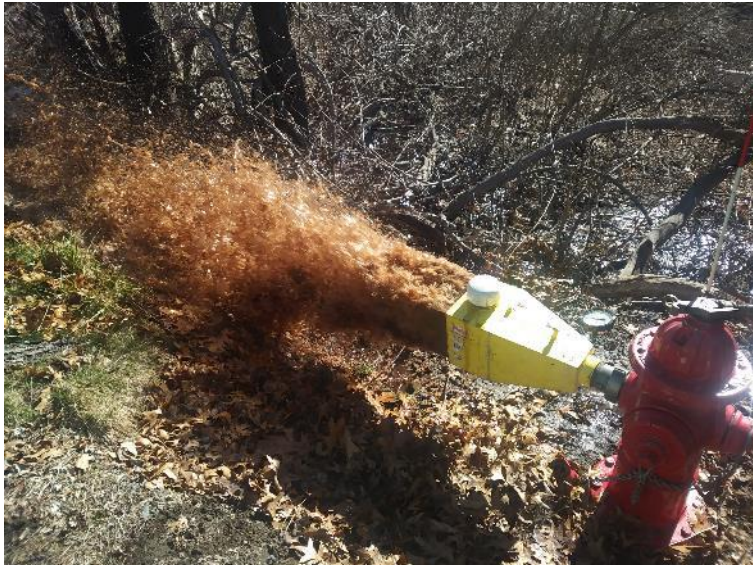
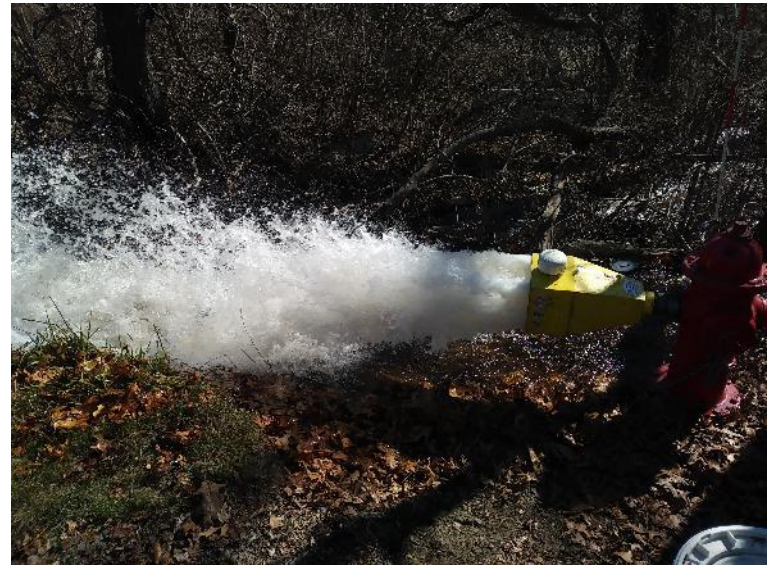
- **Manganese**
 - Manganese is commonly found in groundwater
 - Dissolved manganese precipitates in the water mains and at the point of use
 - Characteristic black color

- Guidelines regarding contaminants that may have aesthetic effects (such as taste, odor, or color) in drinking water.
- Scituate's manganese concentrations are below the thresholds established by the EPA and MADEP
- Manganese comes from our wells
- Iron comes from our pipes

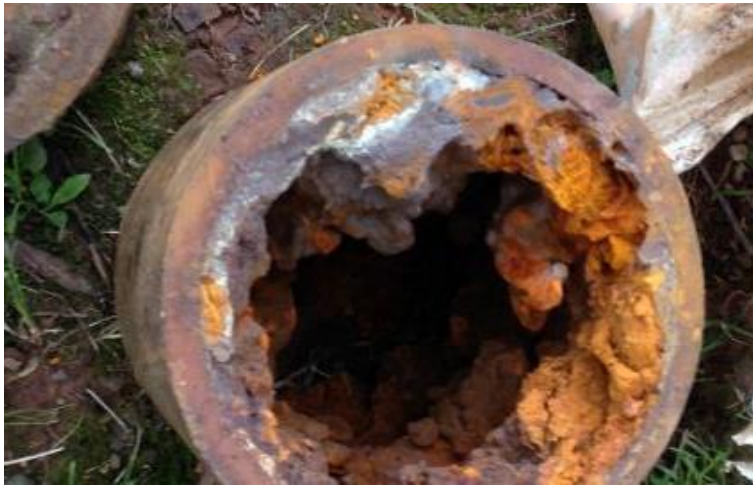
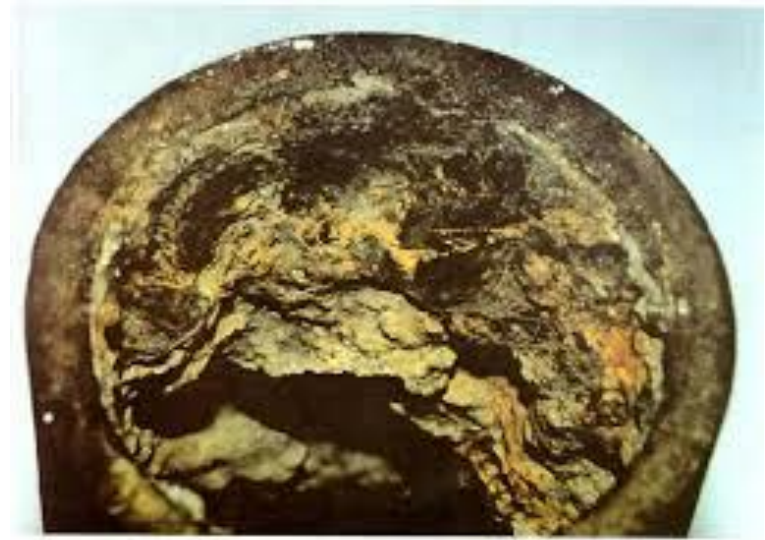
Fig. 8.1. Tuberculation in a cast iron pipe

- Comes from corrosion of cast iron pipe (rust)
- Tuberculation – build up causes rough surface that can accumulate particulate material
- Characteristic red or yellow color

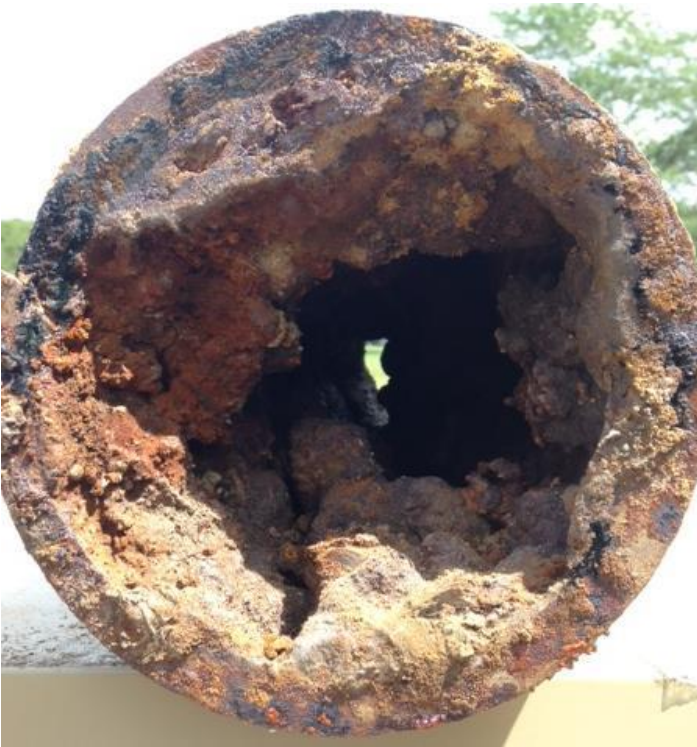
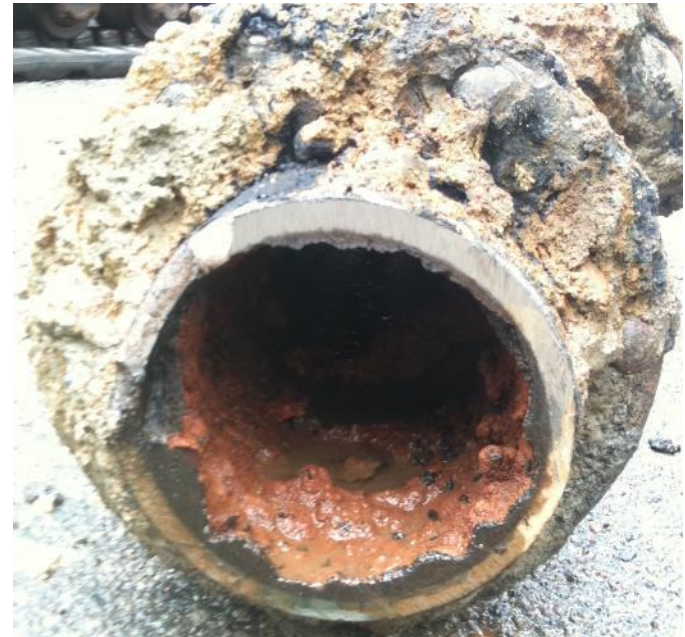
- Some pipes in Scituate's system are almost 100 years old

Examples of tuburculated pipe that has been replaced in Scituate

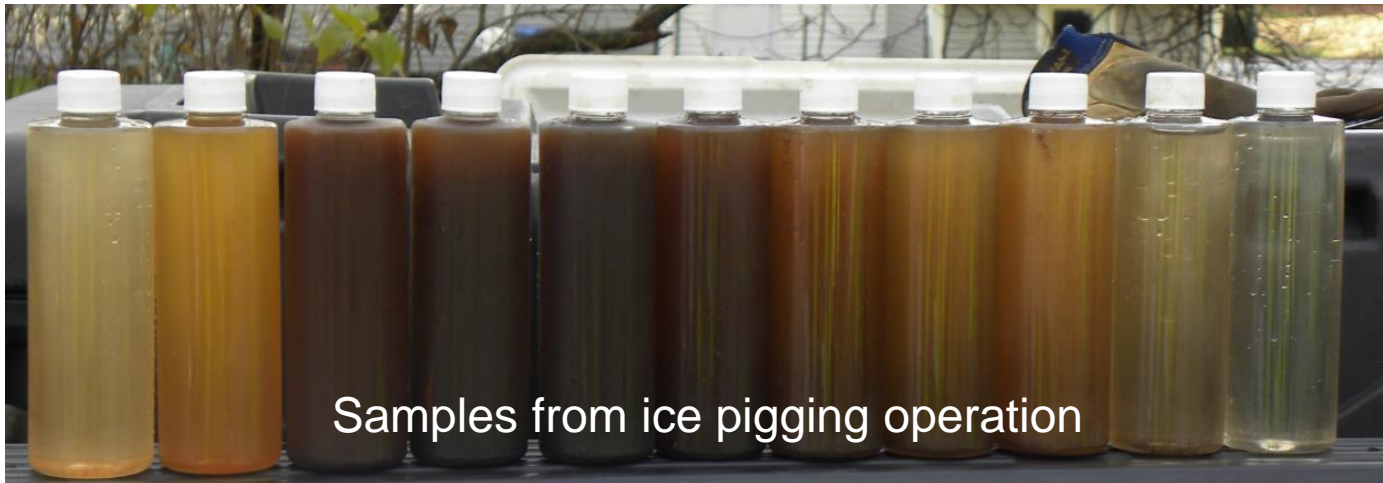
Samples from ice pigging operation

- Water main flushing will continue
- Start ice pigging this fall/winter
 - Relatively new
 - Can effectively treat symptoms
 - Currently developing program
